STAINLESS STEEL EXHAUST SYSTEM

installation instructions		Part Number: SES9300MD	
YEAR	MAKE	MODEL	ENGINE
2021-2024	FORD	BRONCO (2DR & 4DR)	L4-2.3L TURBO
2021-2024	FORD	BRONCO (2DR & 4DR)	V6-2.7L TWIN TURBO

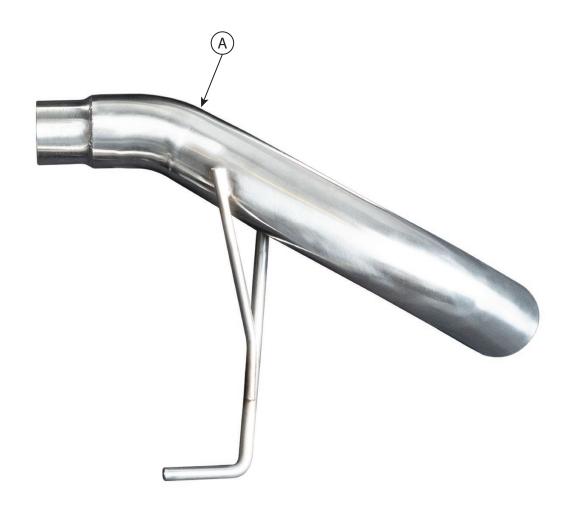
PARTS INCLUDED

ITEM	QTY	PART NO.	DESCRIPTION
А	1	W-SES9300MD	Muffler delete pipe

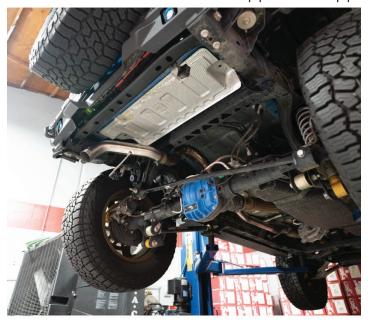
3. Secure the muffler delete pipe using the OEM clamp.

completed the installation of this exhaust system. Periodically, check the alignment of the exhaust, normal wear and tear can cause nuts and bolts to come loose. Note: Check clearance and adjust if needed! Failure to check the alignment and adjust the exhaust can cause damage that will void the warranty. Injen Technology is not responsible for any damages caused by/from improper installation.
