Part number SES2300RS
2020-25 Toyota Supra
MK5 A90
3.0L turbo 6cyl.

- 1- 3 piece cat back single exit exhaust
- 1- 3.25 Torsion Clamp 86mm (#1720)
- 2- 3.5" V band clamps (#17206-C)
- 1- Black zip tie (#8014)

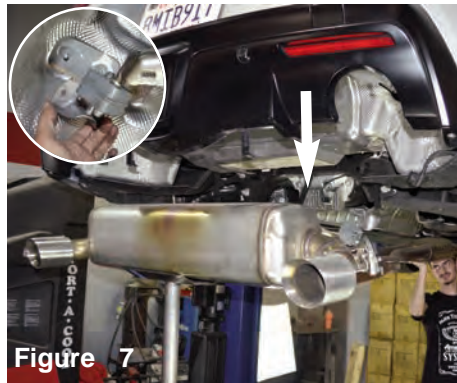
Figure 7
You can now remove the exhaust from the 3 factory hangers and remove the complete exhaust from the vehicle.

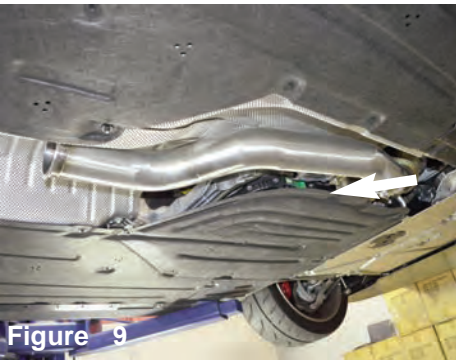
Figure 9
Adjust and set into position. Do not tighten. **Note: Exhaust system has room for adjustment, reposition and tighten for best fit.**

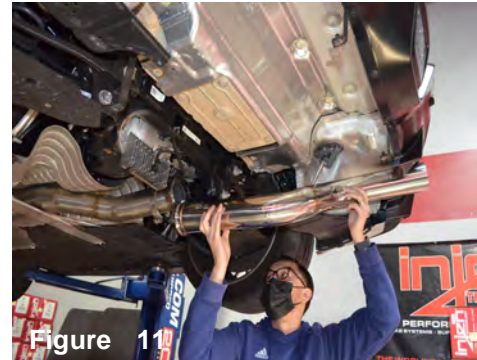
Figure 11
install the rear-section and secure using V band clamps. Do not tighten. place exhaust hanger to the rubber isolator. **Note: Exhaust system has room for adjustment, reposition and tighten for best fit.**

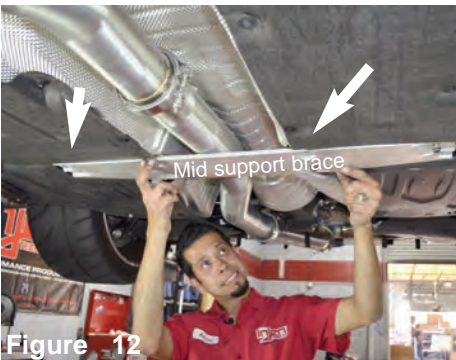
Figure 12
Reinstall the mid support brace. Secure and tighten. Once completed, adjust the mid pipe to have clearance and make sure the pipe does not come into contact with the brace.

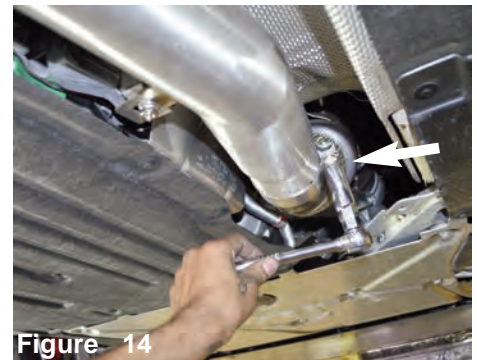
Figure 14
Now once completed, adjustment and clearance, tighten all clamps using 17mm and 13mm sockets. Readjust and reposition if necessary.

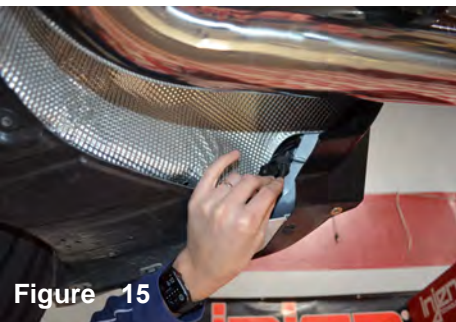
Figure 15
Use the provided zip tie to secure the valve harness and tuck in to rear bumper

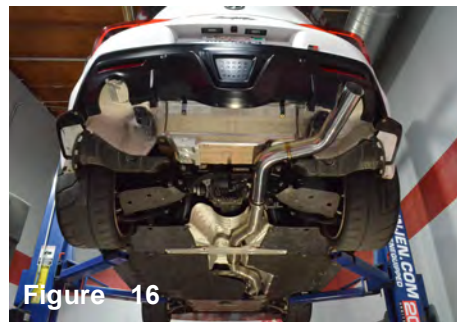
Figure 16

Congratulations! You have just completed the installation of this exhaust system. Verify and adjust the rear section of the exhaust, make sure muffler and tip do not touch any plastics or it can melt. Periodically, check the alignment of the exhaust, normal wear and tear can cause nuts and bolts to come loose. **Note: Check clearance and adjust if needed! Failure to check the alignment and adjust the exhaust can cause damage that will void the warranty. Injen Technology is not responsible for any damages caused by/from improper installation.**
